Project File Report

Humber Flats SWMF 1-4 Rehabilitation Municipal Class Environmental Assessment

February 2025 | TYLin Project 0010651

City of Richmond Hill

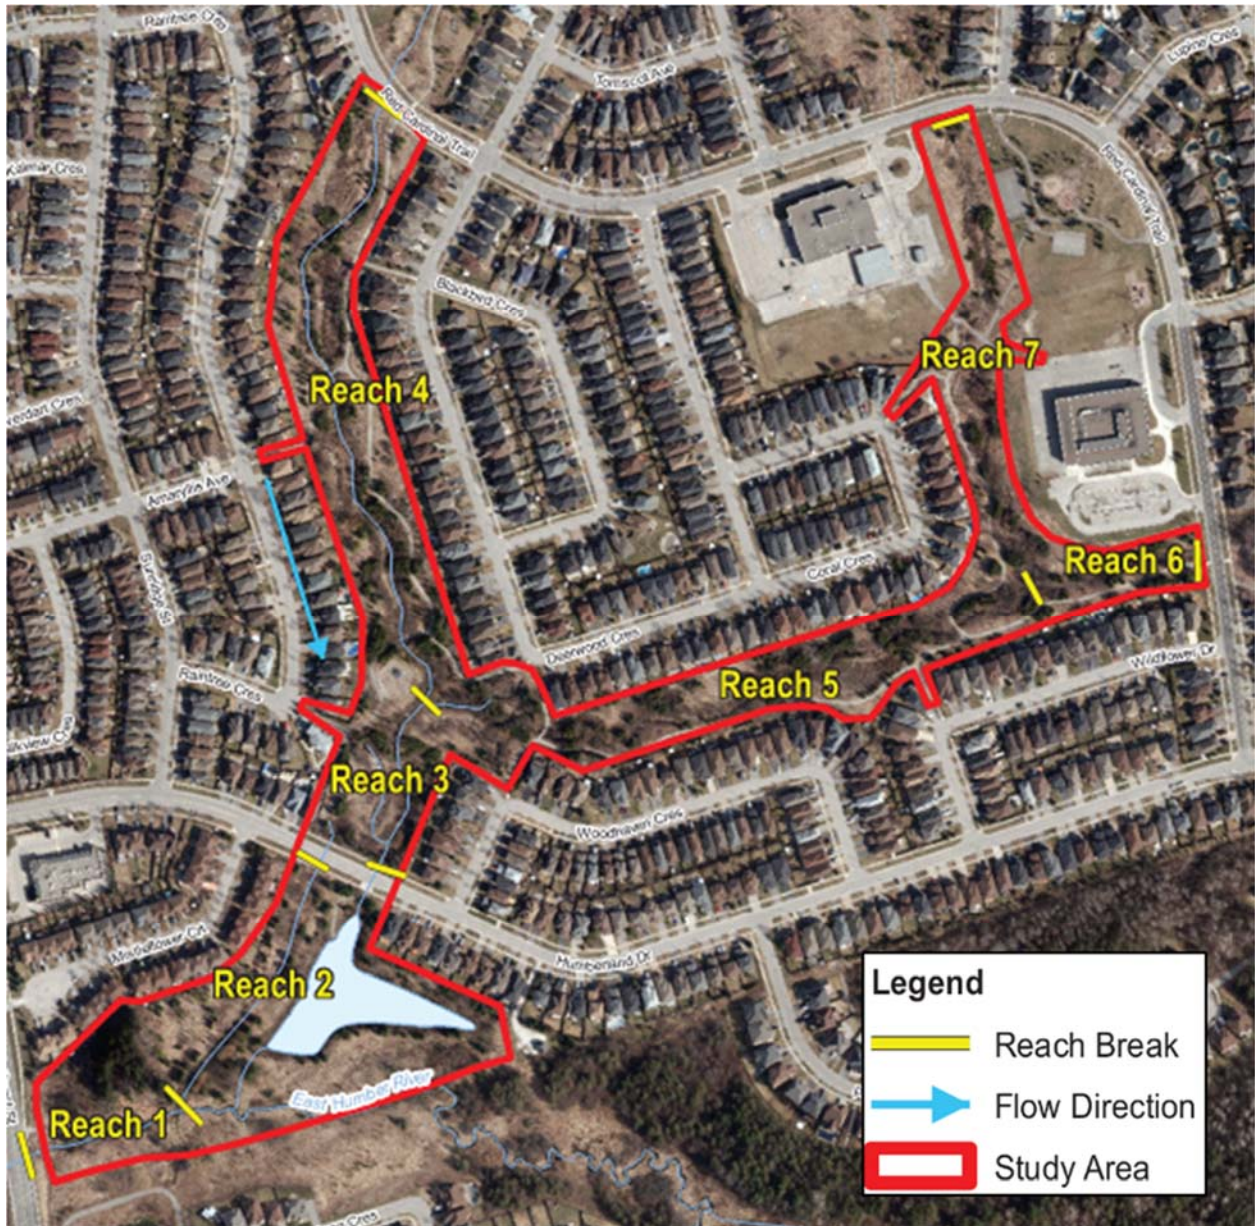
Figure 2-7 Geomorphic Assessment Study Area

There were no fluvial geomorphic erosion issues identified within the study area due to a lack of defined watercourse aside from the downstream reach along the East Humber River. The watercourses through the Ecopark were in constructed trapezoidal valleys with no defined bed and banks. The tributaries had low gradients and were heavily vegetated. Plane bed morphology was dominant through the study area and there was no pool and riffle sequence. Bed material consisted primarily of clay, silt, and sand, with scattered cobble sized rip rap near the filter pads.

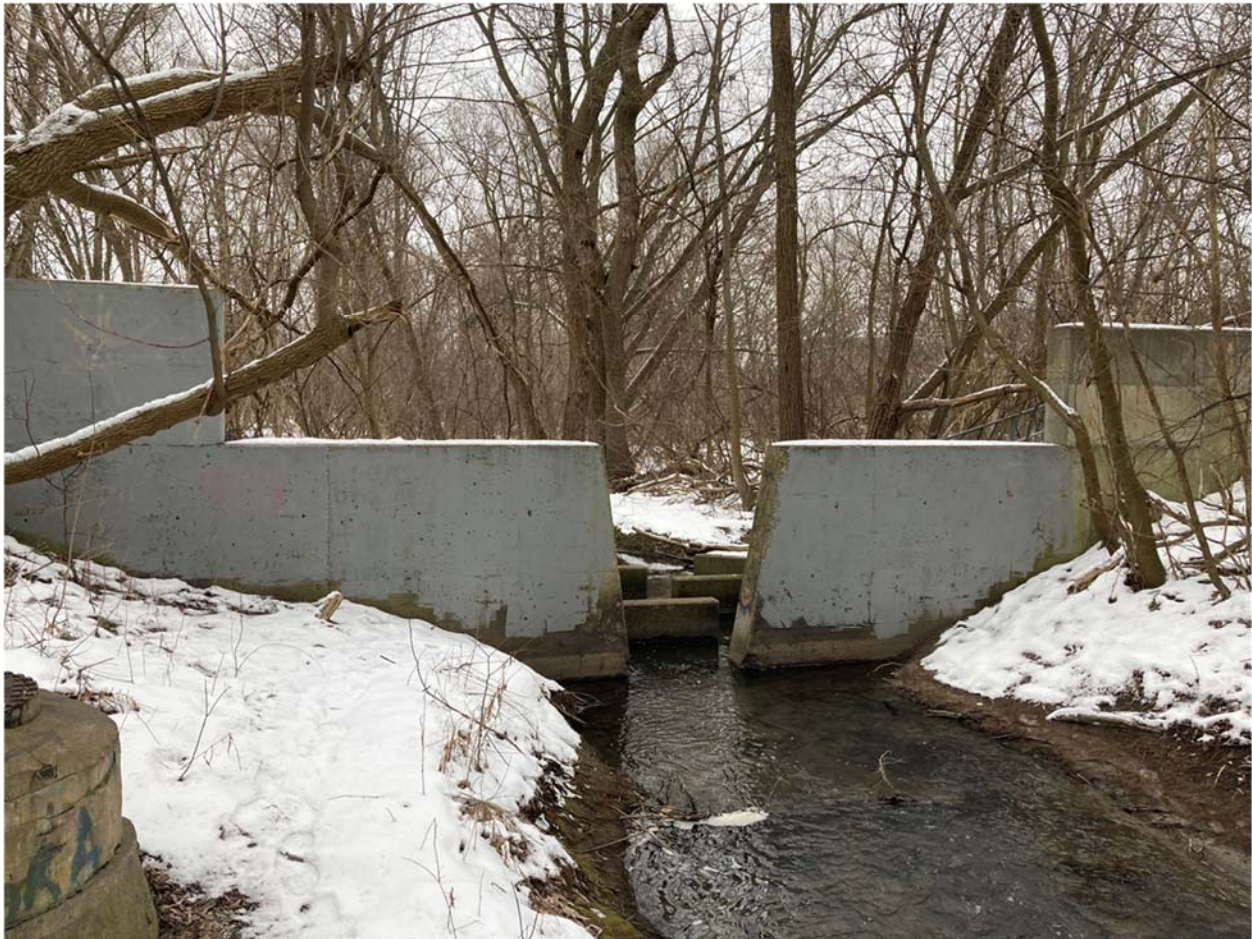
Figure 3-5 Typical On-Line Flow Control Weir (SWMF 24-2)

The maximum water levels behind the on-line flow control structure would be only 2 cm to 3 cm higher than existing for the return period storm events, and therefore would have a negligible impact on the frequency and depth of flooding at the existing playground north of Humberland Drive.
